Rock Mass Classification and Probability of Failure in Determining Slope Stability

Nurul Fitriah Rahmah^{1,*}, Danu Mirza², R. Calvin Maharza³, and S.Koesnaryo⁴

^{1,2,3,4}Universitas Pembangunan Nasional Veteran Yogyakarta, Indonesia

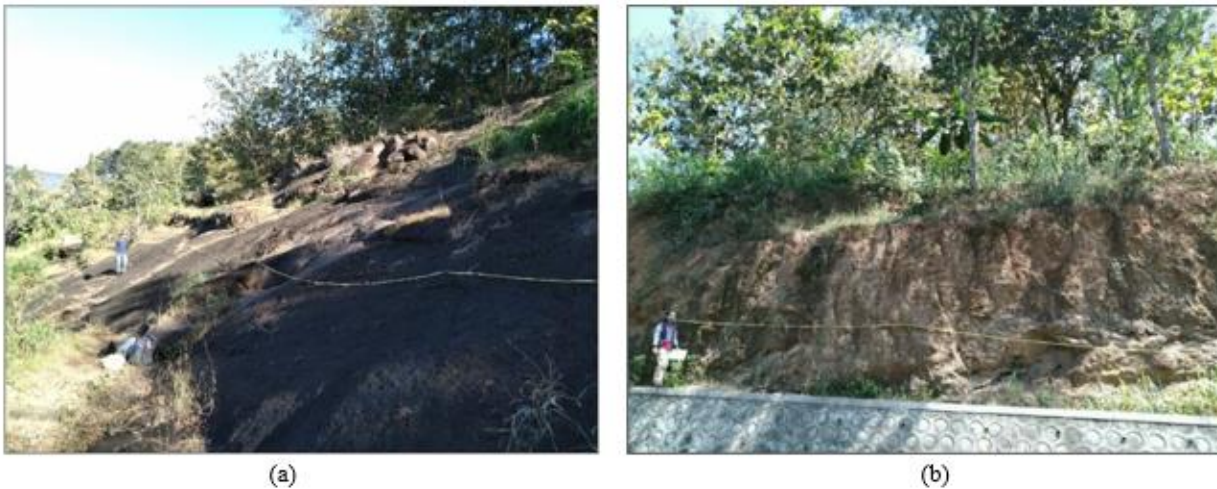
Figure 3. (a) Slope of Hargomulyo Hamlet (b) Slope of Ngalang Hamlet

Location 1 is a fresh breccia andesite slope, whereas Location 2 is a weathered breccia andesite slope. Tables 3 and 4 offer a summary of the tabulation of RMR values at site 1 and position 2.

The appearance of the slopes at locations 1 and 2 is shown in (Figure 3), and the results of the slope stability calculation are shown in (Figure 4).

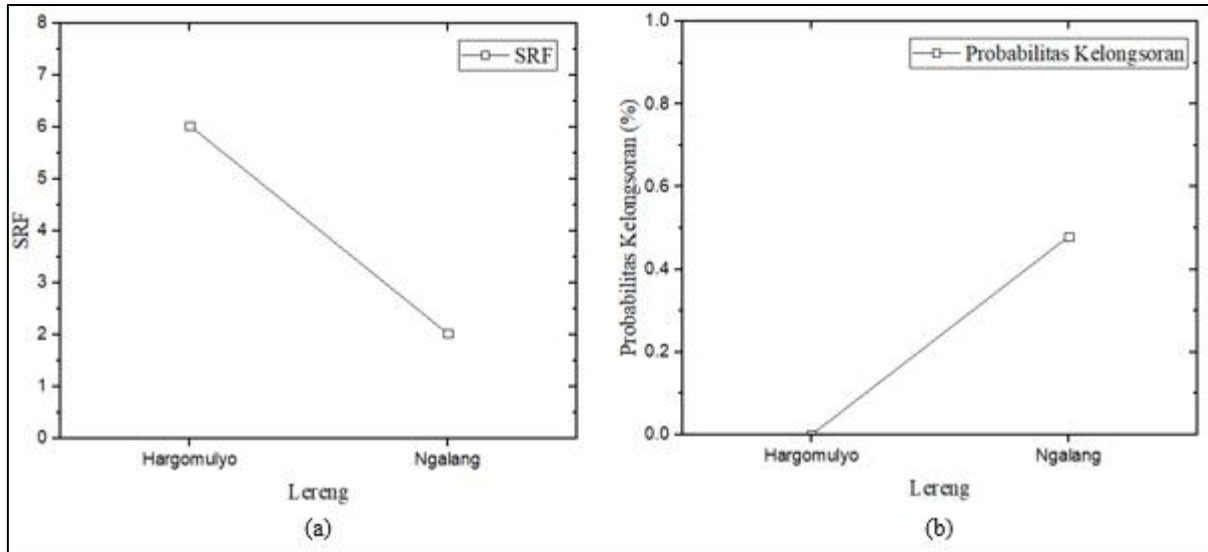
Figure 4. (a) SRF Hargomulyo and Ngalang slopes (b) PoF Hargomulyo and Ngalang slopes

Figure 3 indicates that both slopes are safe, with SRF greater than 1.5. (Slope of Hargomulyo Hamlet with SRF 6.03, PoF 0 percent and Ngalang Hamlet Slope with SRF 2.02, PoF 0.48 percent). The Hargomulyo Hamlet, on the other hand, is in better shape than the Slope of the Ngalang Hamlet. This is proportional to the first estimate of slope stability using the rock mass characterisation technique with RMR and GSI. The slope rock mass of Hargomulyo Hamlet was classed as good by both rock mass categorization methods, whereas the slope of Ngalang Hamlet was classified as fair.

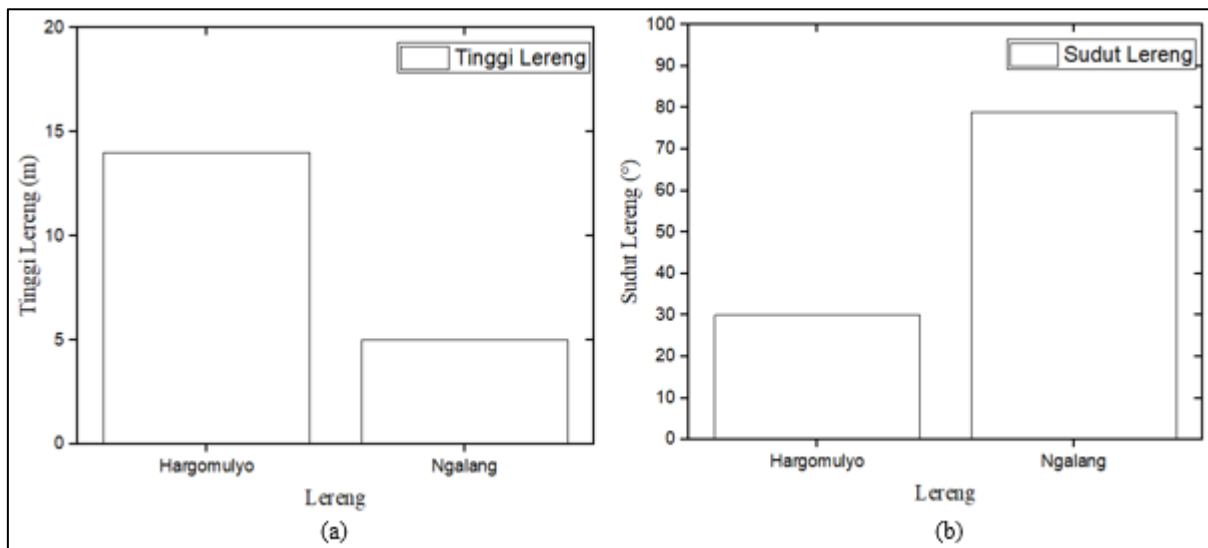
Figure 5. (a) The height of the Hargomulyo and Ngalang slopes (b) The angle of the Hargomulyo and Ngalang slopes

Aside from rock mass classification, another technique was used to determine the source of the discrepancy in SRF values between the two slopes, as shown in (Figure 5).

A geometric approach is used to compare the two slopes, and Figure 4 shows that the slopes of Hargomulyo hamlet have a single slope of 14 meters, which is higher than the slopes of Ngalang hamlet, which has a single slope of 5 meters; however, the slopes of Hargomulyo hamlet have a single slope angle that is gentler, which is 30°, and the slope of Ngalang village has a single slope angle of 79°. According to the geometric method, the angle of the slope is an essential aspect that might affect the level of slope stability. Even though the single slope height in Ngalang village is 5 meters, the load received by the slopes is more than the load received by the slopes in Hargomulyo hamlet with a

single slope height. 14 meters with a single slope angle of 30 degrees. So lowering the slopes by reducing the angle of the single slope is one technique to strengthen the stability of the slopes in the Ngalang hamlet.
